# 2025 SANITARY SURVEY REPORT

## Rosa Joint Ventures Water System NM3500324

Prepared by: Gordon Miller— Compliance Officer  
New Mexico Environment Department  
1800 E. 30th Street, Suite B  
Farmington, NM 87401

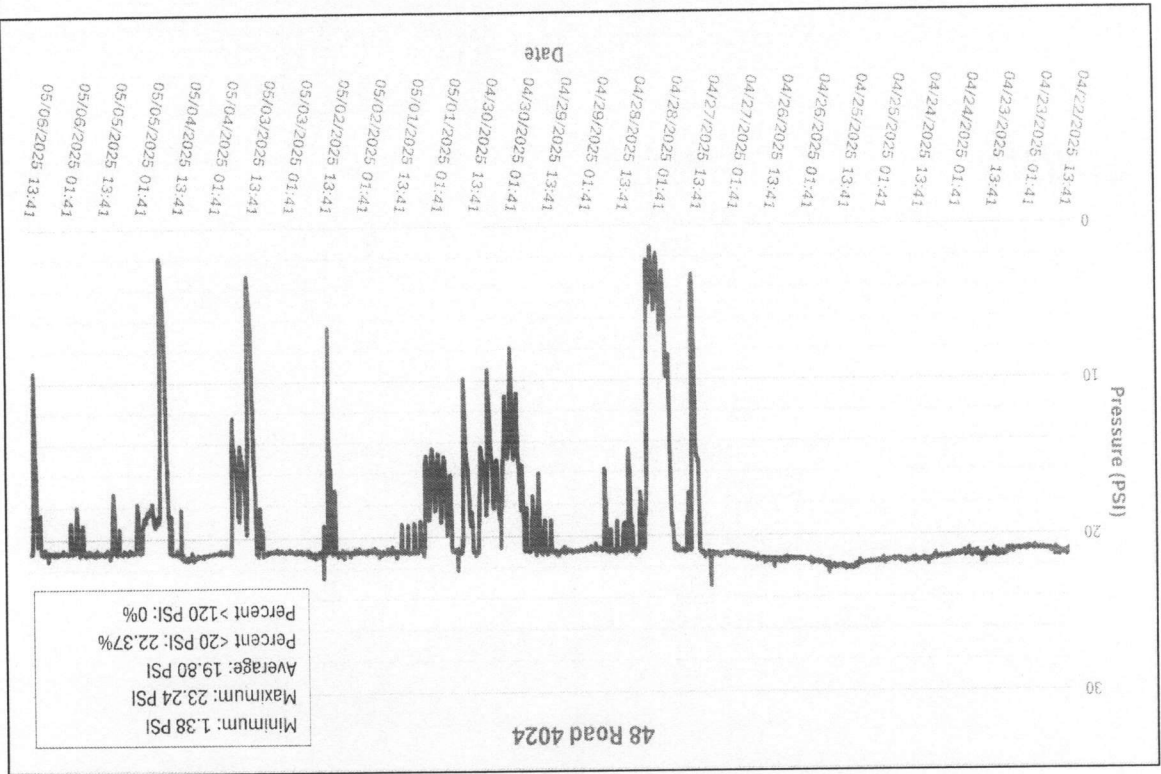
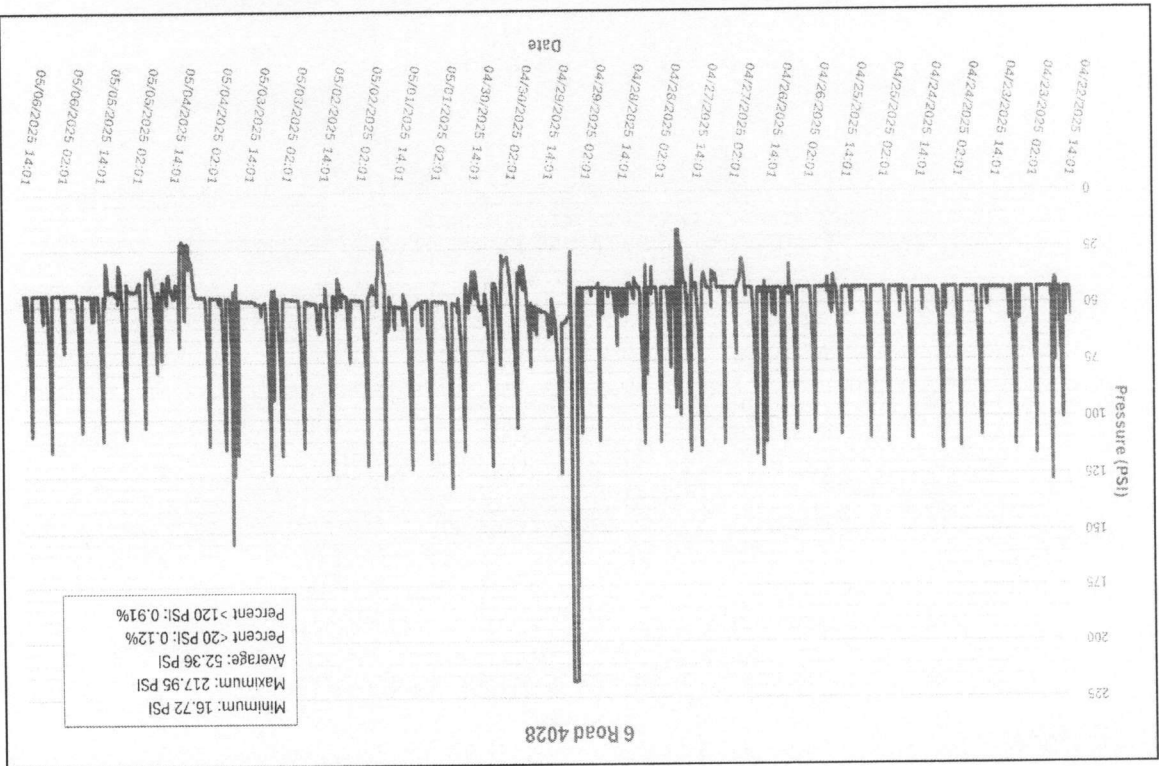
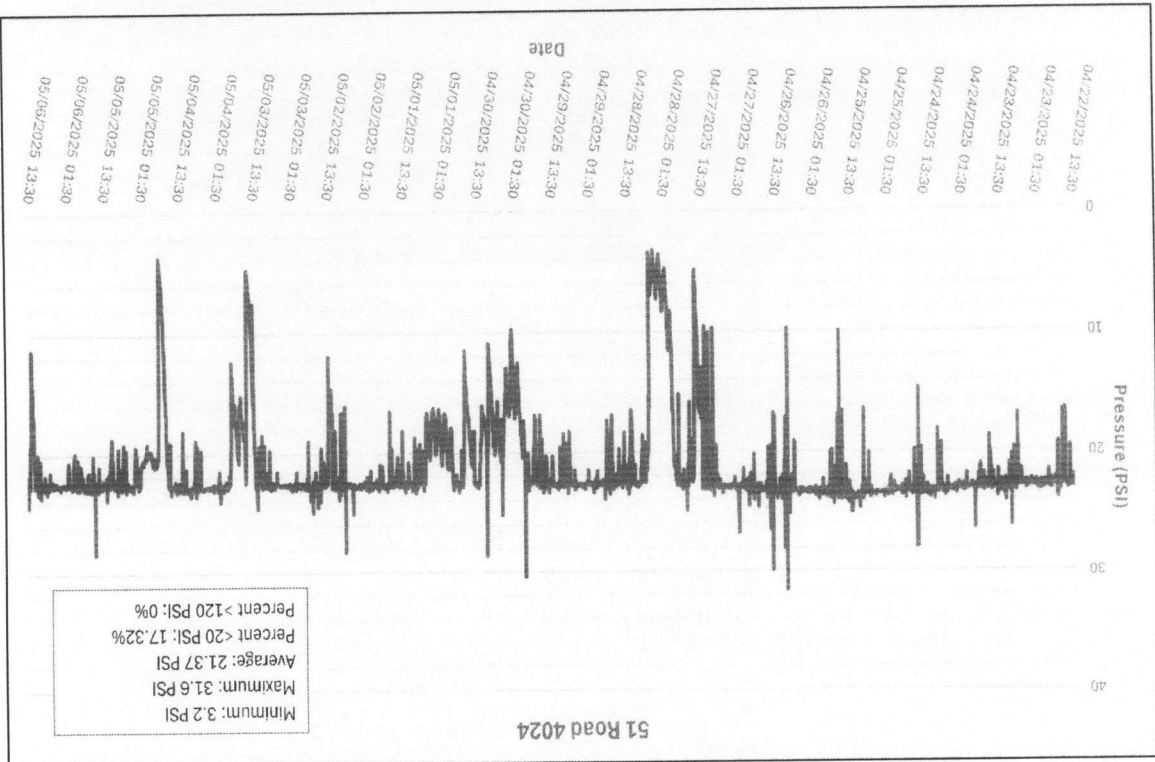
☐ Pressure – Pressure data loggers were deployed at multiple locations throughout the distribution system and left in place for approximately two (2) weeks. 6 Road 4028 is located in the Lakeview Heights side of the distribution system and 48 and 51 Road 4024 are located in the Rosa Meadows side of the distribution system. The results are shown below:

Over an approximately two (2) week period of time collecting a data point every five (5) minutes, 22.37 percent and 17.32 percent of measurements were under twenty (20) psi pressure in the Rosa Meadows side of distribution. Minimums measured at the respective locations were 1.38 PSI and 3.20 PSI, far below what is considered adequate pressure in a Public Water System distribution system. Averages of 19.80 PSI and 21.37 PSI respectively indicate that typical pressure is on the low end of what is considered adequate. Graphs of the entire data set collected can be seen in the Field Analysis section of this sanitary survey report.

Lack of storage facility water level indicators, manual operation of well and booster pumps, and relatively low production rates from the wells contribute to frequent low pressures in distribution.

Inadequate pressure in distribution increases the likelihood of backflow into the distribution system and potential for contamination.

**Required Corrective Action:** The Rosa Joint Ventures Water System must submit documentation acceptable to WPCFB indicating that adequate pressure is regularly being provided in distribution.

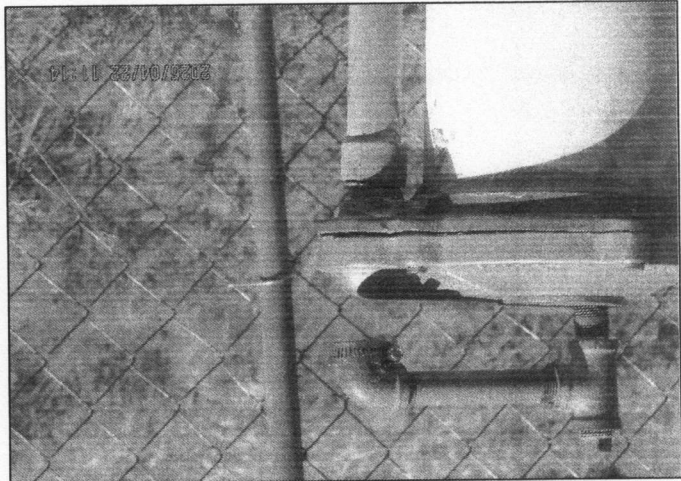
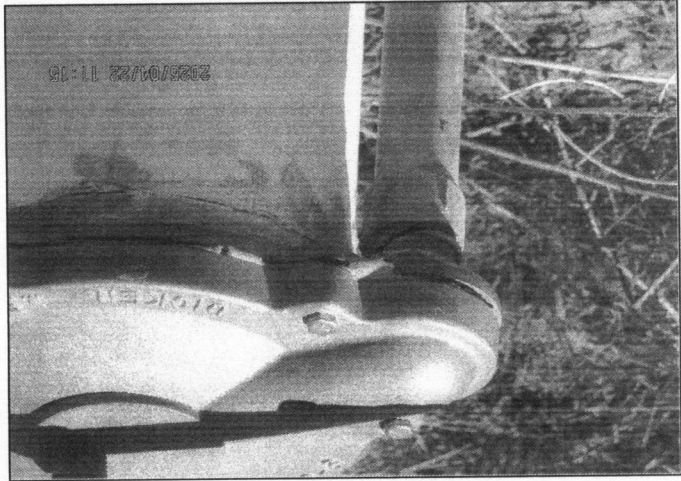
### 1. Significant Deficiency Code: 001L – Well head not properly sealed.

**Significant Deficiency Description:** On the day of the sanitary survey, it was observed that the electrical conduit was cracked and the sanitary well seal on the Meadow Well (#00324001) did not form a complete seal. The sanitary well seal appeared to have been sealed with caulk at one point, but the seal failed. An improperly sealed well head can allow non-potable water, insects, or vermin into the well and potentially contaminate the well and aquifer.

**Required Corrective Action:** The Rosa Joint Ventures Water System must submit photographs acceptable to WPCFB indicating that the sanitary well seal for the Meadow Well is equipped with a gasket and all bolts are tightened forming a complete seal or that the well head has been otherwise appropriately sealed. The Rosa Joint Ventures Water System must also submit photographs acceptable to WPCFB indicating that the electrical conduit for the Meadow Well is completely sealed.

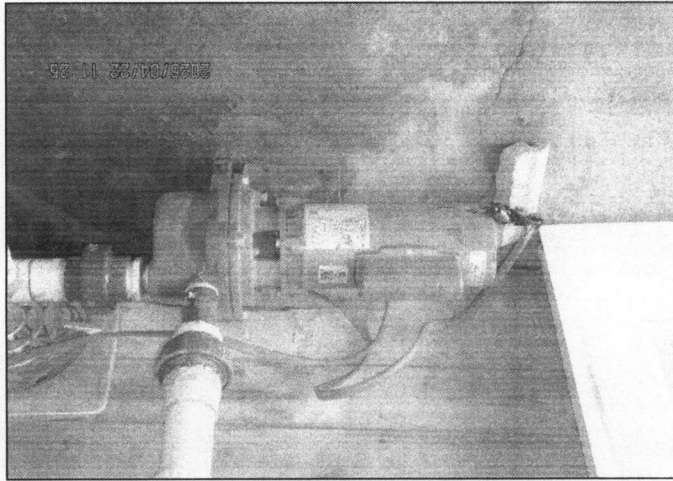
**2. Significant Deficiency Code: 006L – Pump controls not secured from the elements.**

**Significant Deficiency Description:** On the day of the sanitary survey, the wiring for the booster pump located in the Well House (#00324003) was observed to be exposed and lacking proper insulation. The system has a history of pump failures at this location and does not have a backup pump for redundancy. This pump is critical to maintaining adequate pressure in the Rosa Meadows side of distribution.

**Required Corrective Action:** The Rosa Joint Ventures Water System must submit a photograph acceptable to WPCFB indicating that the wiring for the booster pump in the Well House (#00324003) has been properly secured from the elements and that there is no exposed wiring.

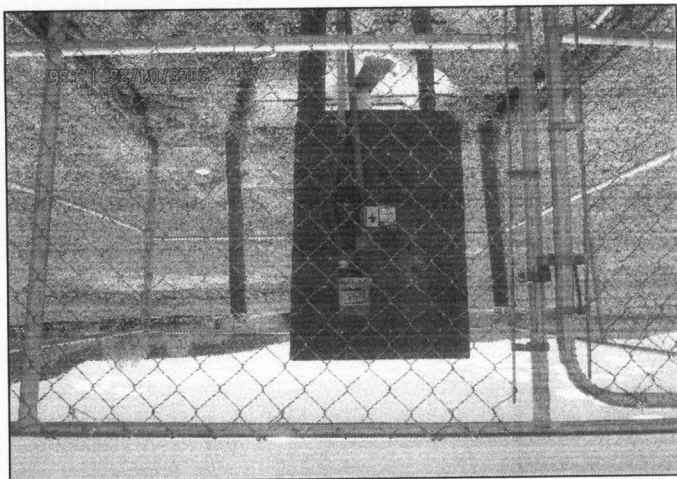
**3. Significant Deficiency Code: 001D – Inoperable controls at source facility.**

**Significant Deficiency Description:** On the day of the sanitary survey, it was observed that an electrical capacitor in the pump controls for the Nob Well (#00324004) had failed and the well was out of service.

**Required Corrective Action:** The Rosa Joint Ventures Water System must submit a photograph or other documentation acceptable to WPCCB indicating that the electrical capacitor has been replaced in the pump controls for the Nob Well (#00324004) and the well is operational.
